WATER STORAGE TANKS

Inspection Form

Facility: Contentment Island		Date: 6/8/2015
Material: Welded Steel	Type: Standpipe	Shape: Cylinder
Height/Length: 40'	Diameter/Width: 12.5	
Mixing:	SCADA: None

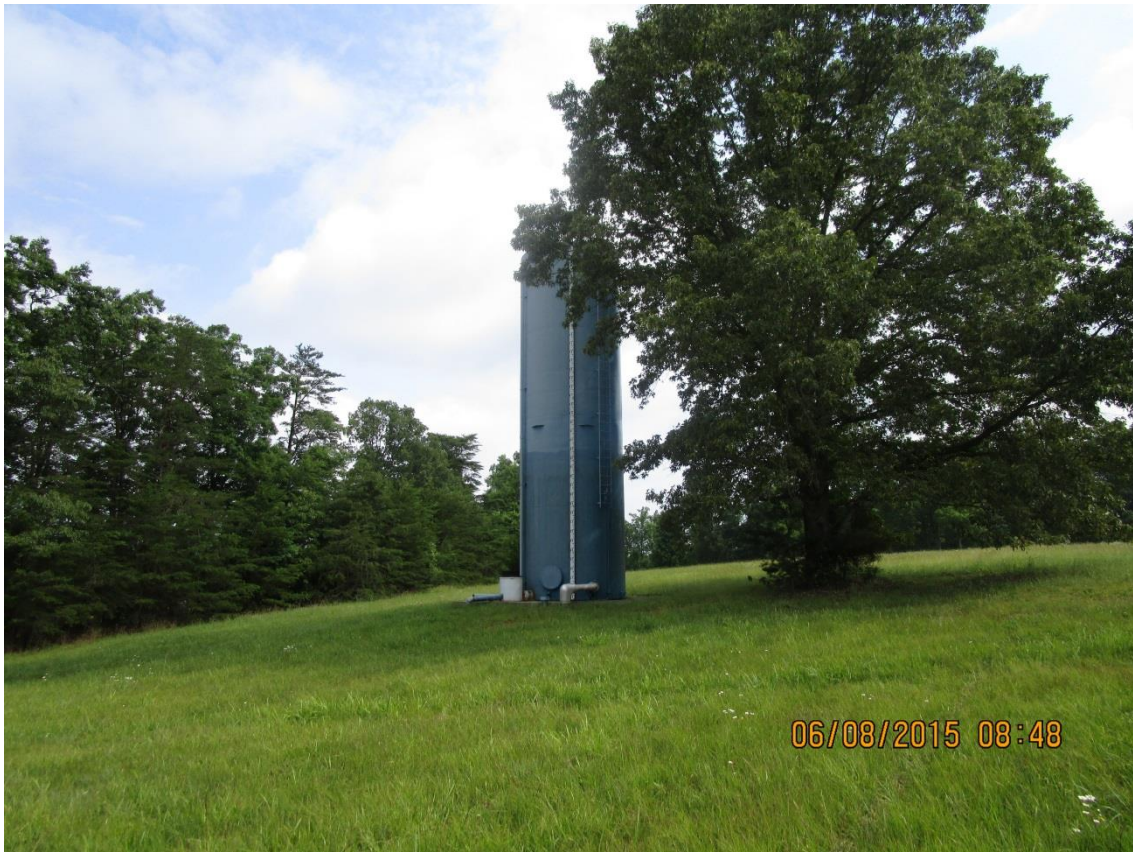
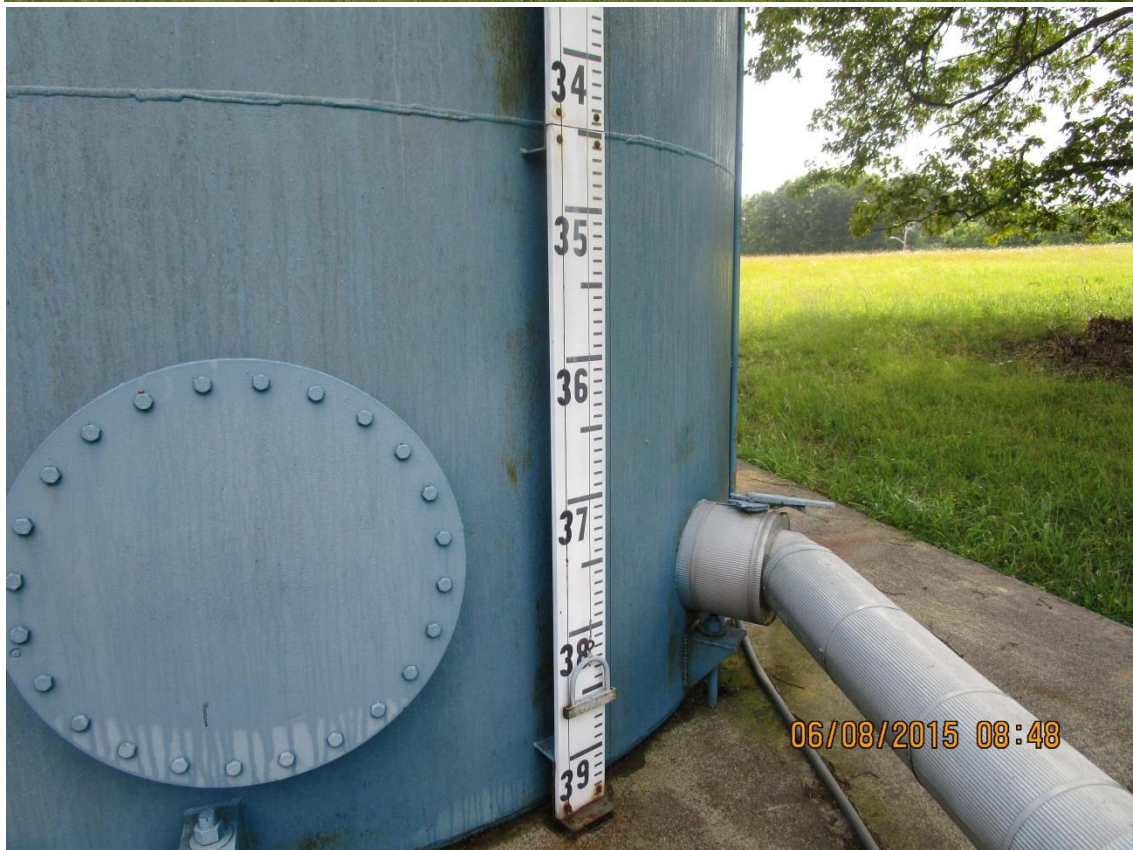
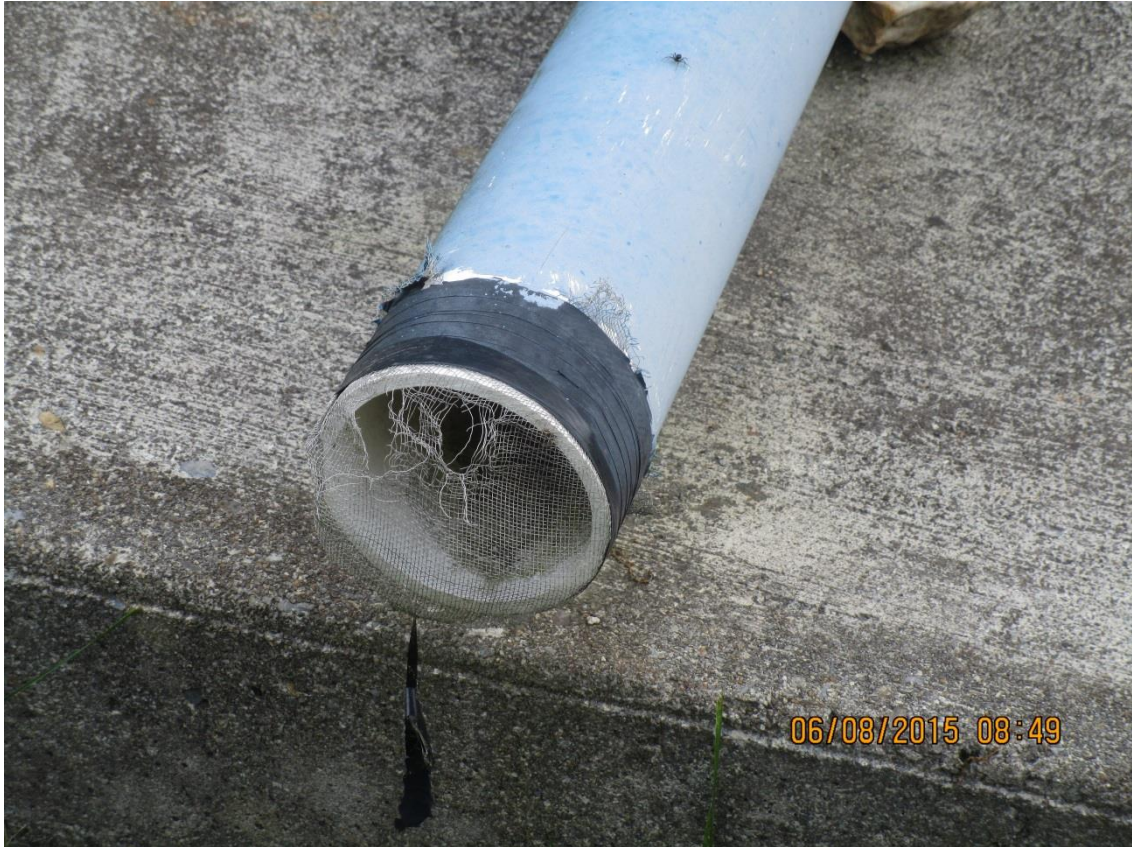
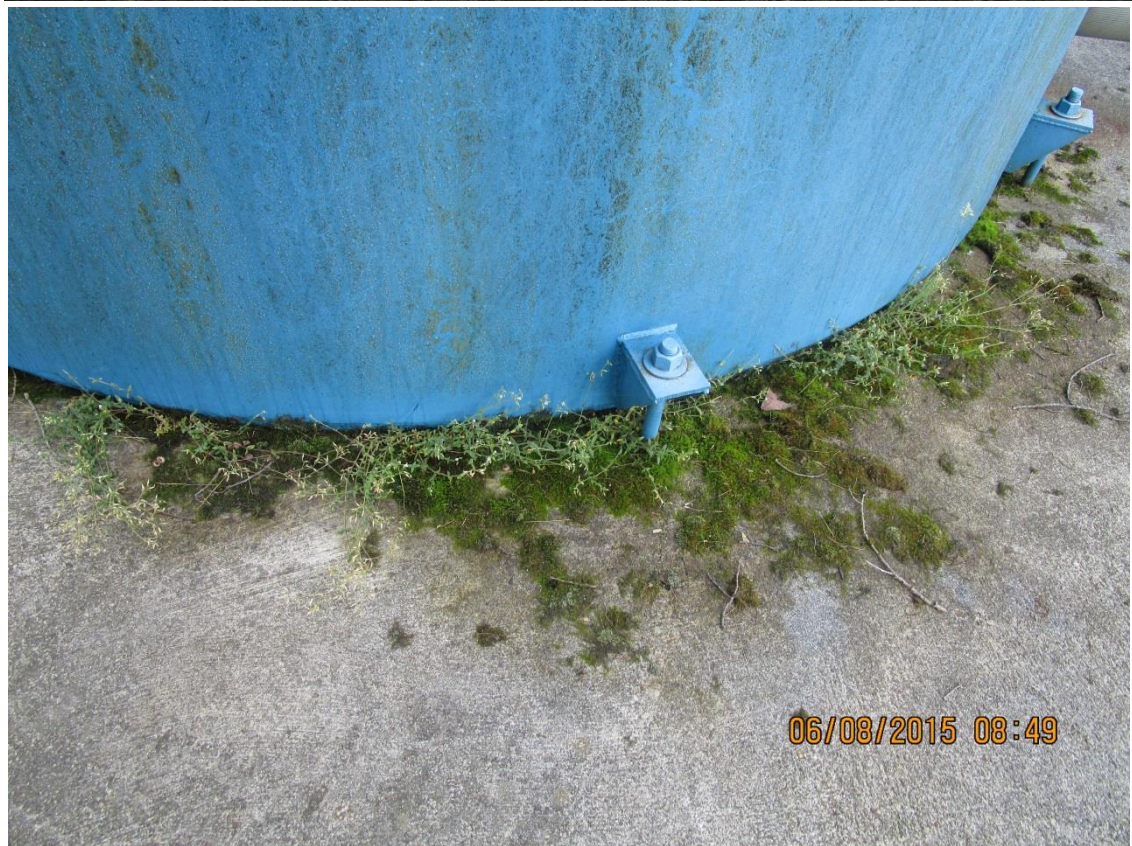
Description	O.K.	Problem	N/A
Foundation: <i>settling, cracks, deterioration, grout</i>		Some vegetation	
Protective Coating: <i>rust, pitting, corrosion, leaks</i>	X		
Water Level Indicator: <i>operable, opening protected</i>	X		
Overflow Pipe: <i>proper size, flap valve cover accessible, operable, sealed, (screened)</i>		Needs new screen	
Access Hatch: <i>size, number</i>		1 @ 24	
Access Ladder: <i>loose bolts or rungs, climbing device</i>	X		
Roof: <i>low spots for ponding water, holes along seams</i>		Not Inspected	
Vents: <i>proper design, screened, sealed edges and seams</i>		Not Inspected	
Cathodic Protection: <i>secured and sealed</i>		Not Inspected	
Roof Hatch: <i>proper design, locked, hinge bolts secured, gasket</i>		Not Inspected

The tank is in good condition, the screens need to be replaced
