SHEET:
9 OF 10

CARVINS COVE DAM BREACH ANALYSIS
DAM BREAK INUNDATION ZONE MAP
BOTETOURT COUNTY, VA

PANEL 8

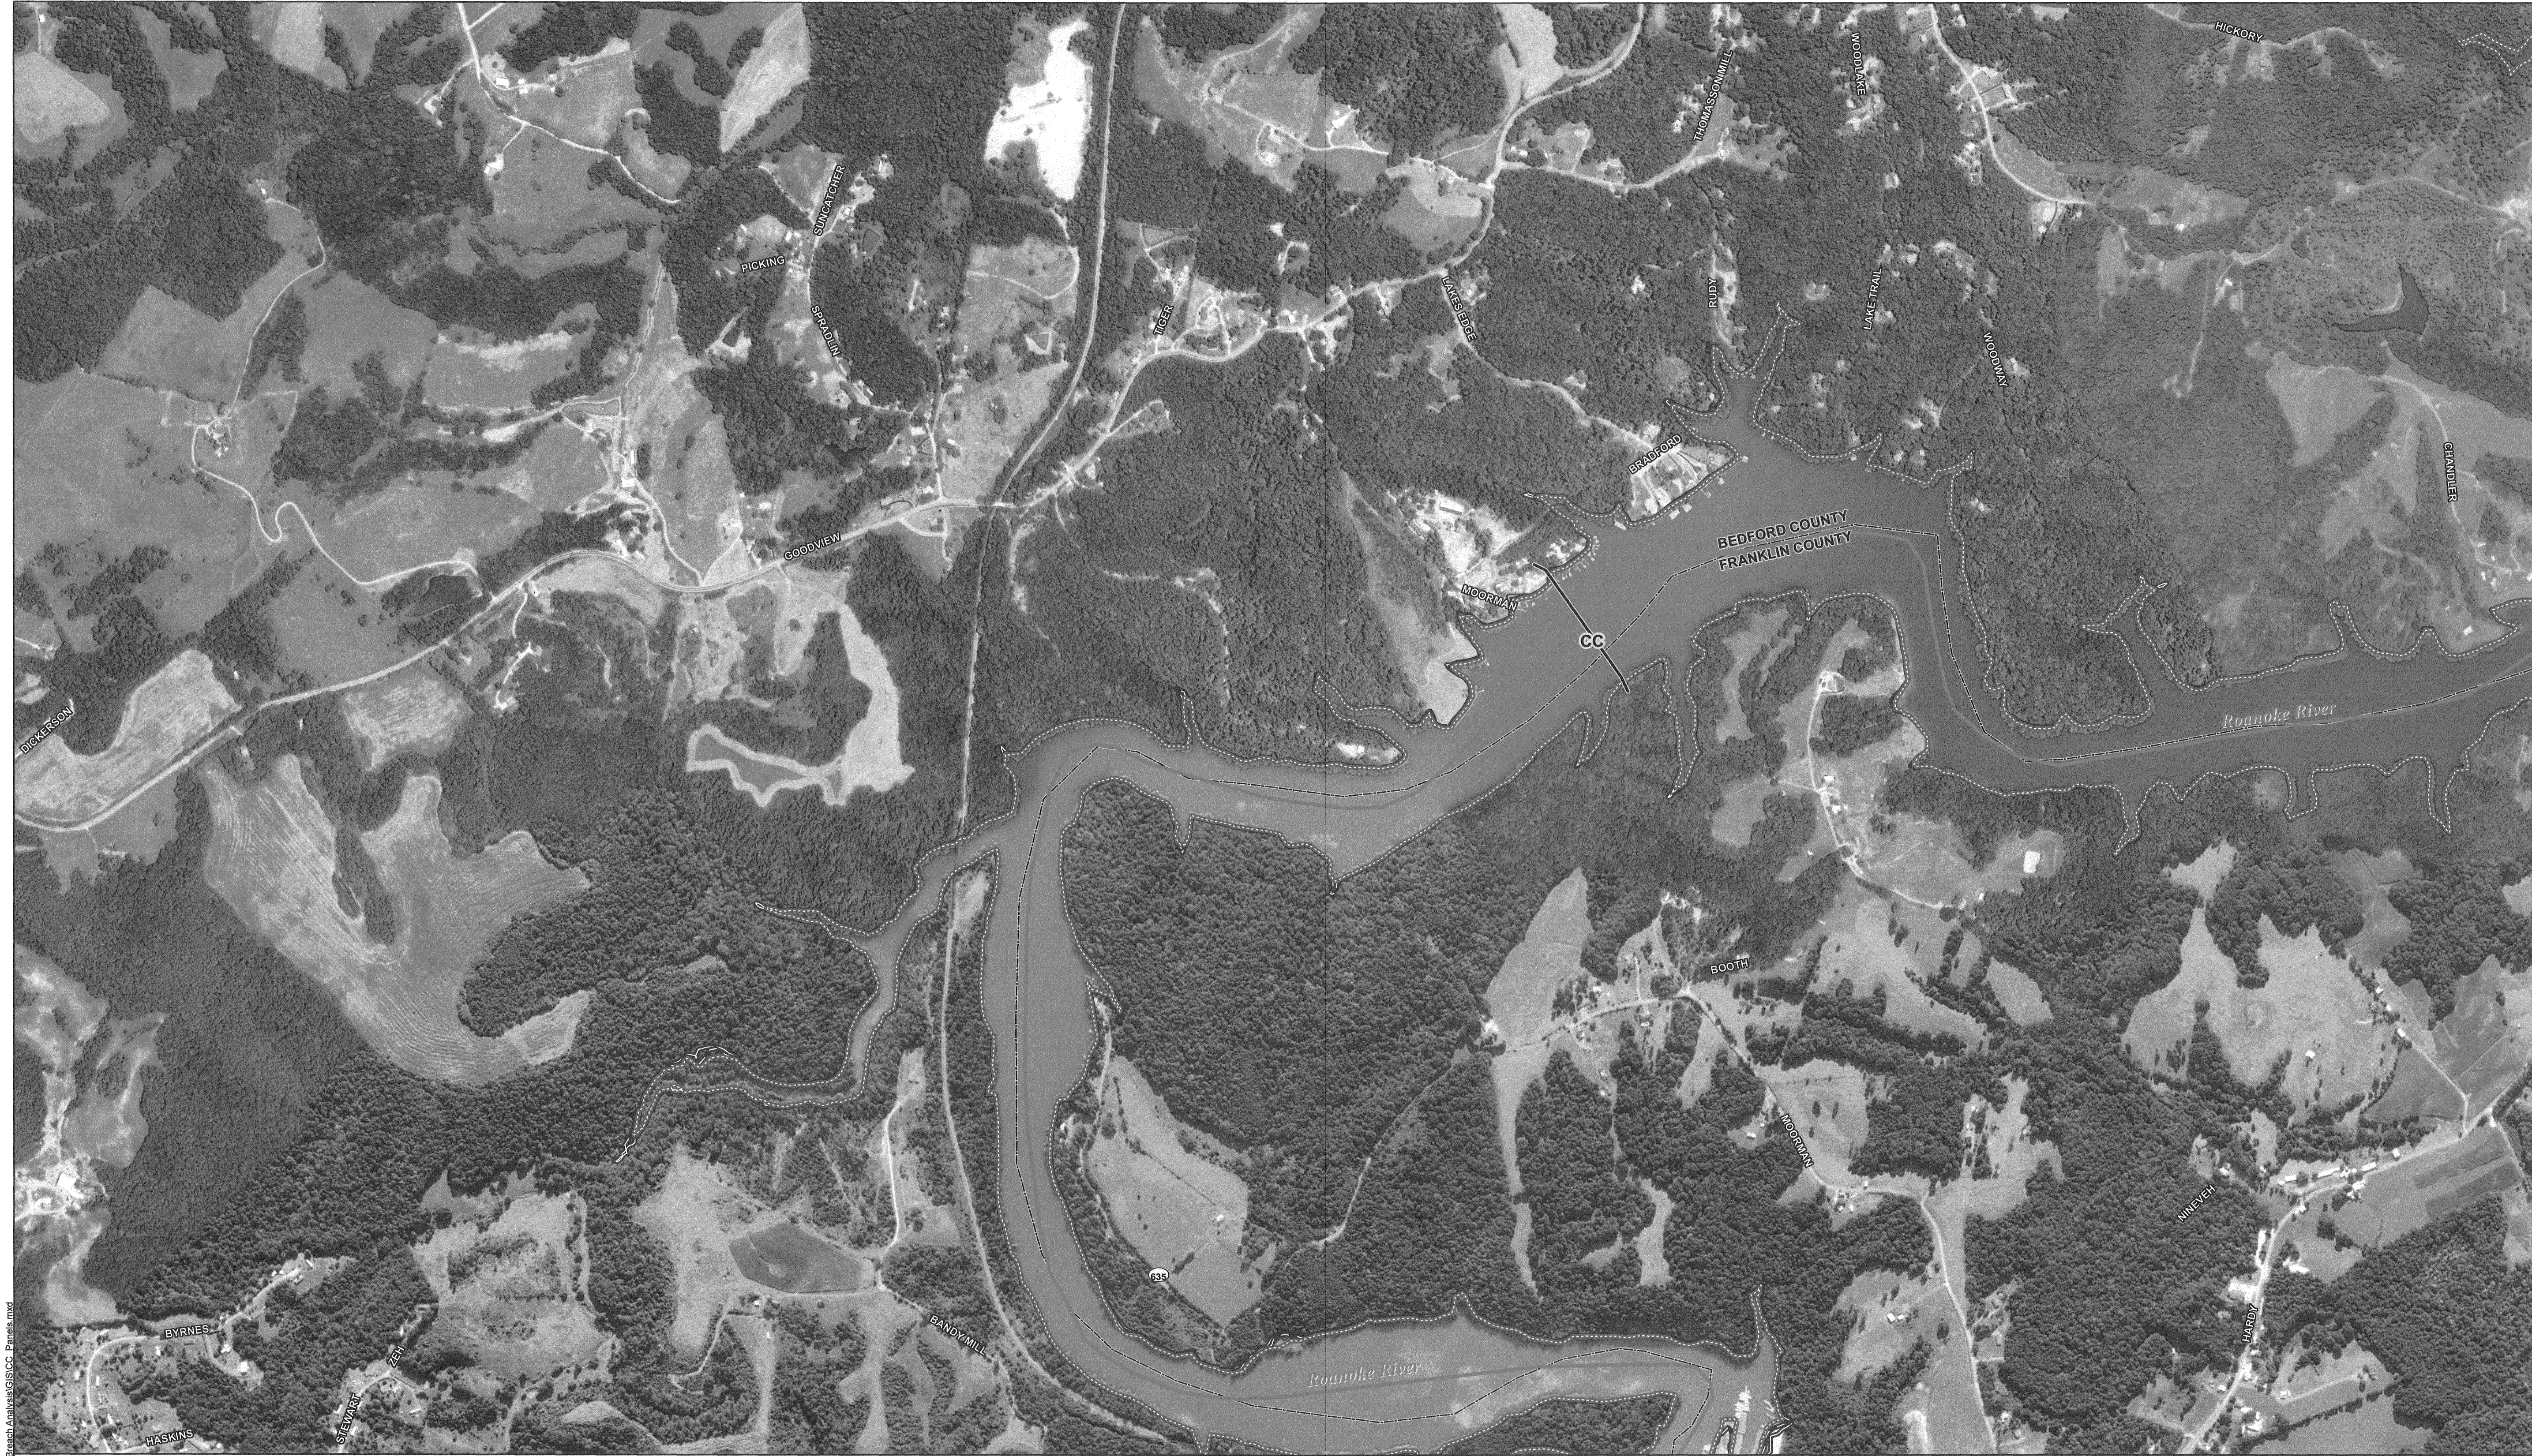
Cross Section	Distance from Dam (miles)
CC	25.1

Sunny Day Dam Breach		
First Flood Waters*	Peak Flood Level*	Depth of Water** (feet)
3:20 (hr:min)	4:28 (hr:min)	49.6

Spillway Design Flood Breach		
First Flood Waters**	Peak Flood Level*	Depth of Water*** (feet)
20:18 (hr:min)	3:58 (hr:min)	52.3
