6/15/2011 G:\2011-SDE\Jobs\1821007_00-Carvins Cove Dam Break Analysis\GIS\CC_Panels.mxd

Sunny Day Dam Breach

Spillway Design Flood Breach

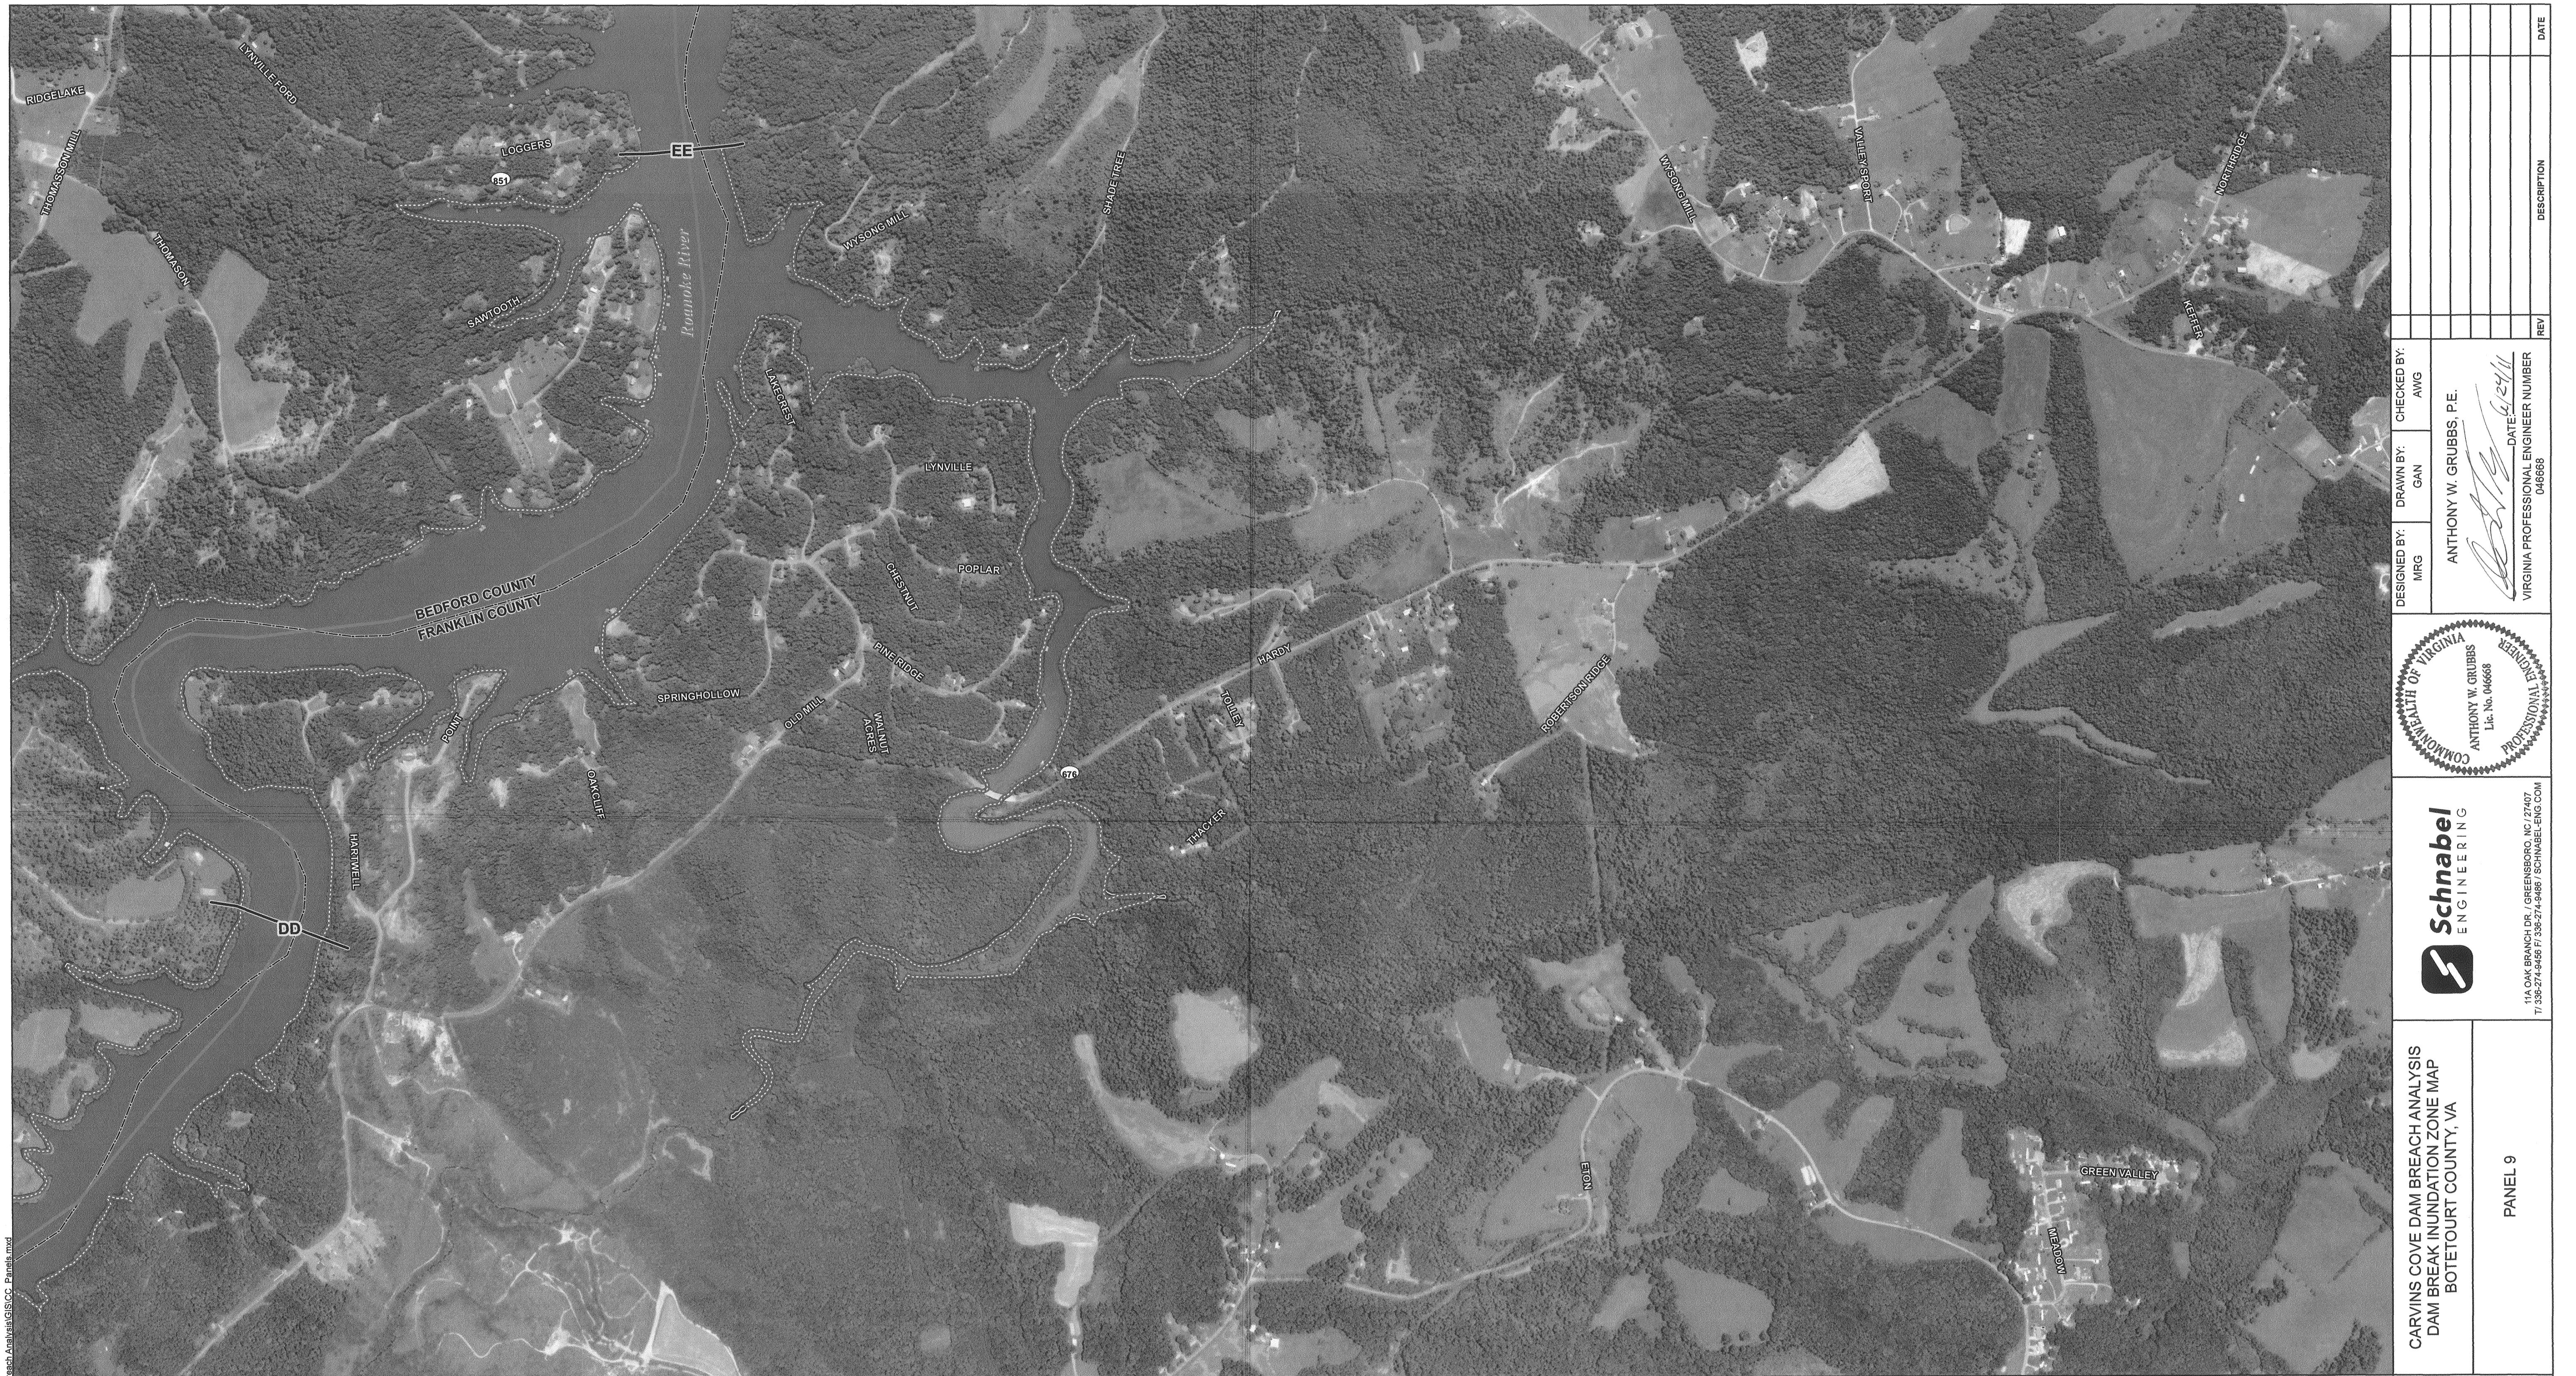
- Cross Section
- Stream
- Spillway Design Flood
- Sunny Day Breach
- Spillway Design Flood With Breach

- The information contained in this map is prepared for use in notification of downstream property owners by emergency management personnel.
- Mapping of flooded areas and floodwave travel times are approximate. Timing and extent of actual inundation may differ from information presented on this map.

- It is prudent to assume that areas outside, but adjacent to, the inundation limits shown could also be flooded.
- Due to the topography, floodwave similarities, and map scale, inundation lines may obscure other inundation lines at some locations on the map.

- The impacted addresses shown on the map are a result of the Spillway Design Flood with Breach.
- Dam break inundation zone maps shall be provided by the owner to the local government for use in review of proposed development plans and zoning.
