WESTERN VIRGINIA  
WATER AUTHORITY

CONTRACT 1 -  
2016 SANITARY SEWER REHABILITATION

Manhole Rehabilitation

Designed By: KJV	Project No: 31237	Drawing No.:
Drawn By: KJV	Scale: AS SHOWN	C-126
Checked By: DBH	Issue Date: October 2016

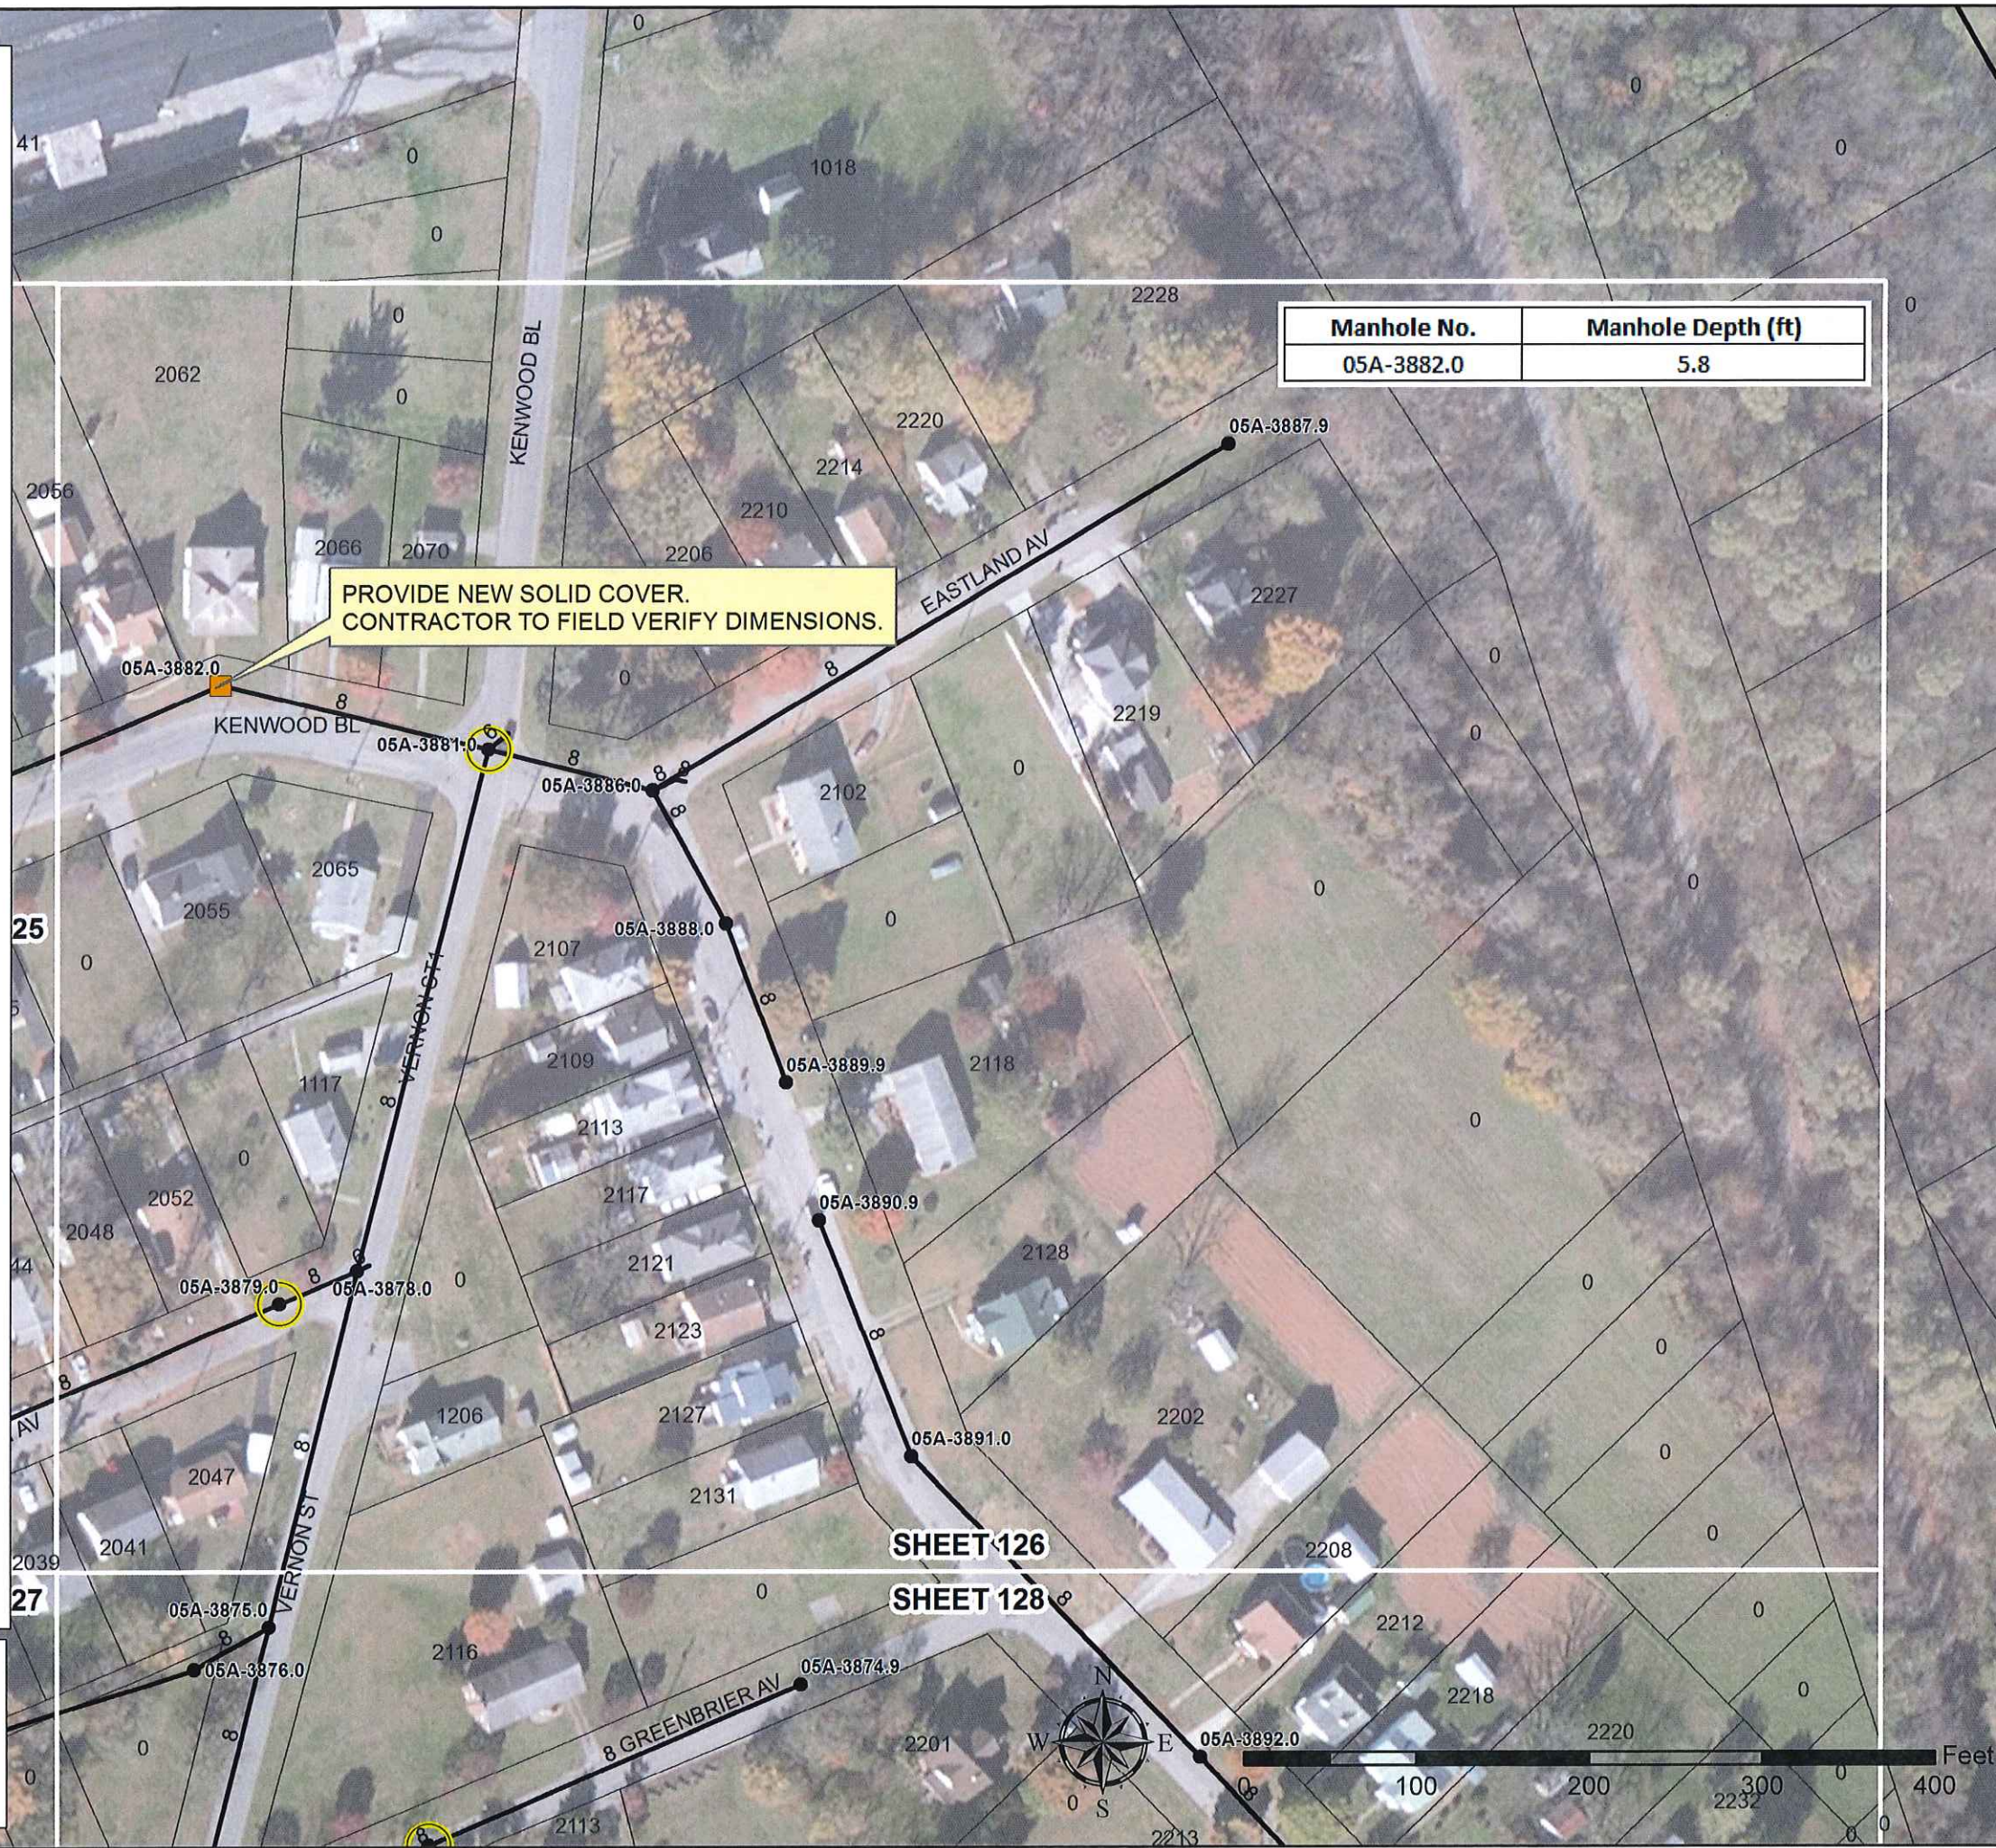
### Sanitary Sewer Rehabilitation

- Line
- Burst
- Lateral Rehabilitation
  - Capped- Do Not Reinstale
  - Replace
  - Replace - Pavement
  - Trim and Replace
  - Trim and Replace - Pavement
  - Trim - Do Not Reinstale
  - Assist Owner to Verify Active - Replace if Active
  - Verify Active - Pavement
  - Existing PVC - Reconnect at Sewer Main
  - Existing PVC - Pavement - Reconnect at Sewer Main

- Install Water-Resistant F&C
- Reseal Existing Frame
- Install Standard F&C
- Seal Chimney
- Cementitiously Line Manhole
- Repair Crack/Holes in Wall
- Seal Pipe Connections
- Seal Wall/Bench Connection
- Repair Crack/Holes in Bench
- Install 8-inch Cleanout

ROANOKE, VIRGINIA  
All 3 lids have holes.
