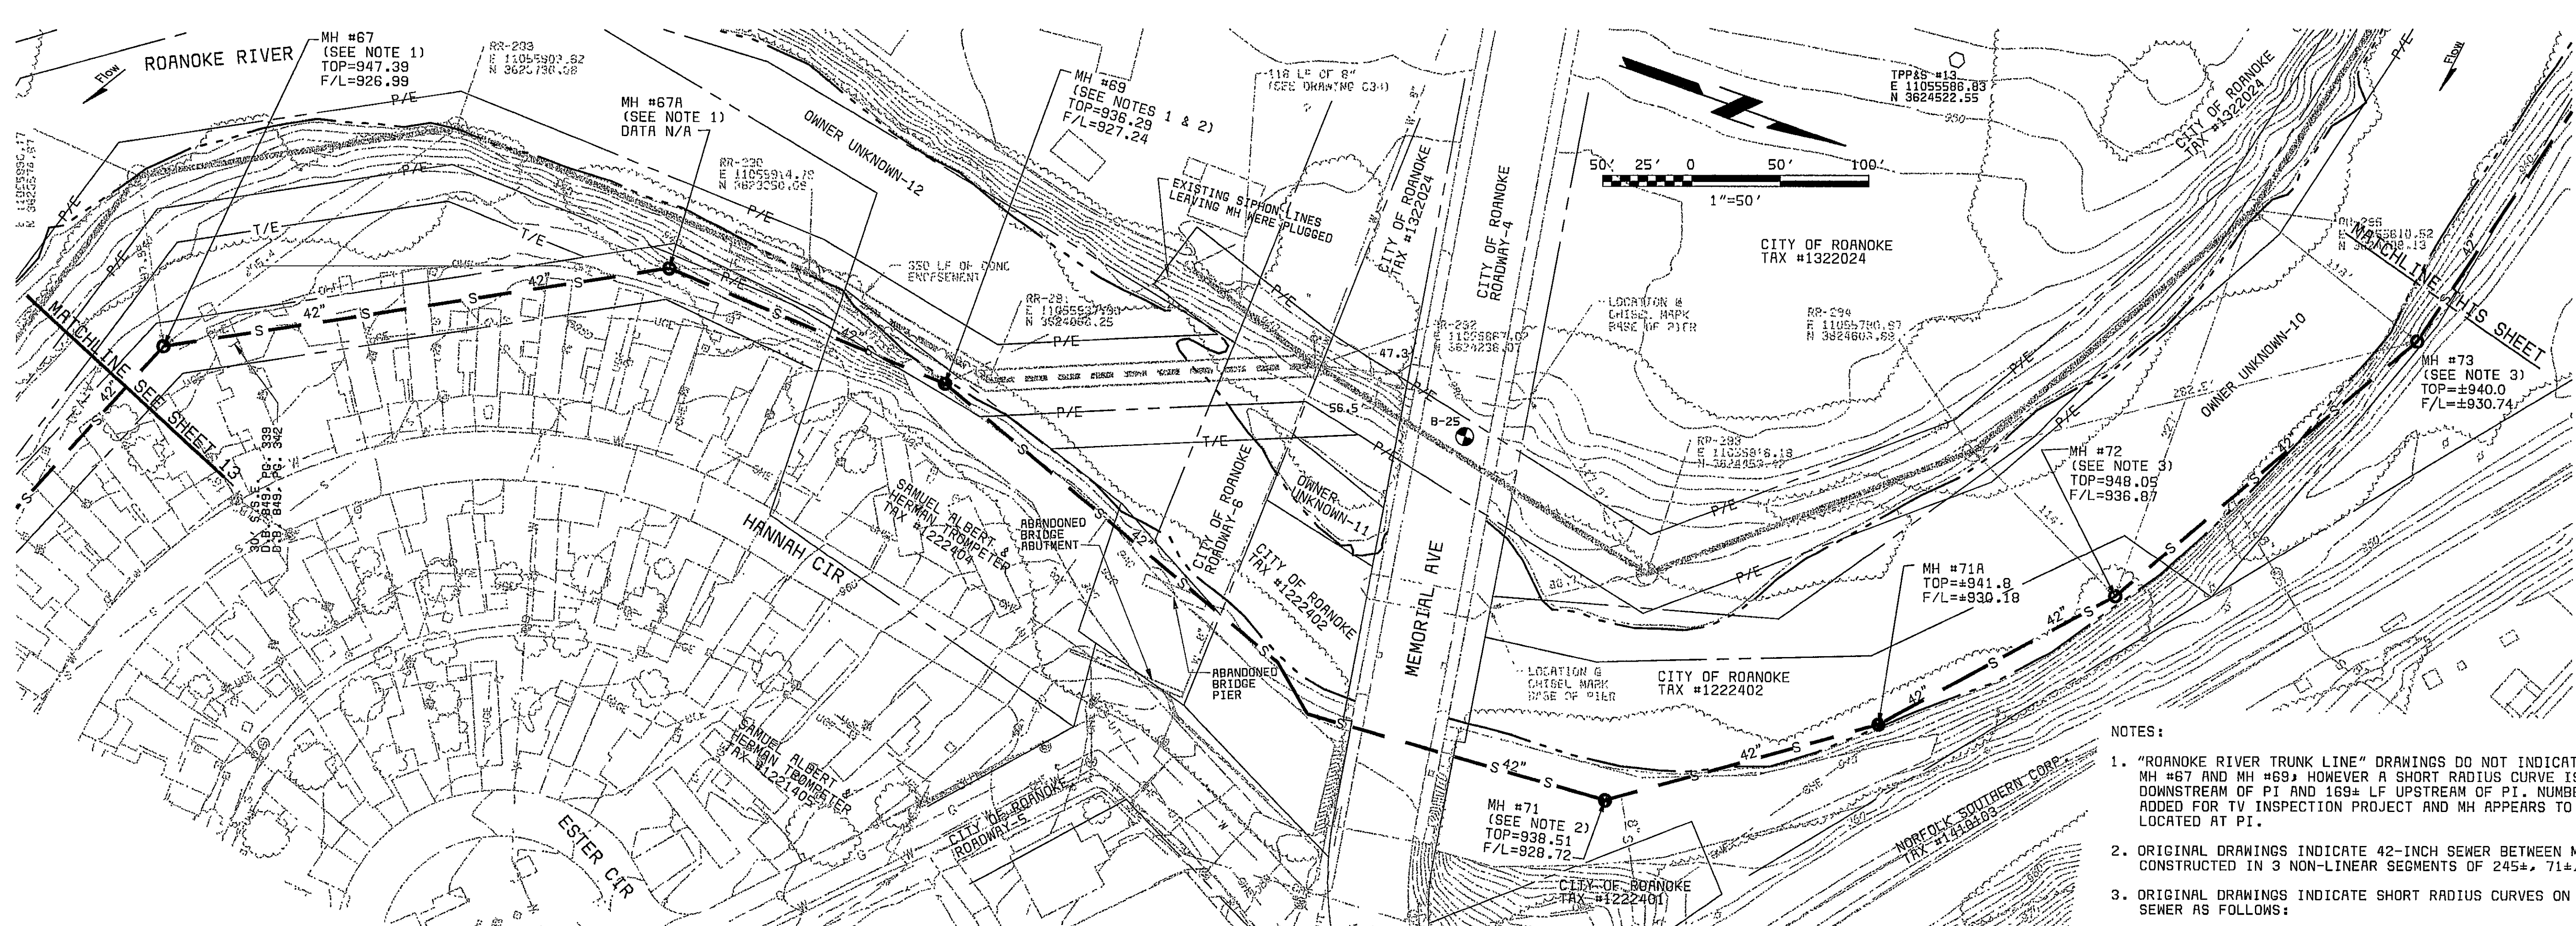
- NOTES:
- "ROANOKE RIVER TRUNK LINE" DRAWINGS DO NOT INDICATE A MANHOLE BETWEEN MH #67 AND MH #69, HOWEVER A SHORT RADIUS CURVE IS SHOWN WITH 289± LF DOWNSTREAM OF PI AND 169± LF UPSTREAM OF PI. NUMBERING FOR MH #67A WAS ADDED FOR TV INSPECTION PROJECT AND MH APPEARS TO BE APPROXIMATELY LOCATED AT PI.

- ORIGINAL DRAWINGS INDICATE 42-INCH SEWER BETWEEN MH #69 AND MH #71 IS CONSTRUCTED IN 3 NON-LINEAR SEGMENTS OF 245±, 71±, AND 175± LF.
  - ORIGINAL DRAWINGS INDICATE SHORT RADIUS CURVES ON EXISTING 42-INCH SEWER AS FOLLOWS:  
MH #72 TO MH #73  
152± LF DOWNSTREAM OF PI  
223± LF UPSTREAM OF PI  
MH #73 TO MH #74  
314± LF DOWNSTREAM OF PI  
103± LF UPSTREAM OF PI

- ORIGINAL DRAWINGS DO NOT INDICATE A MANHOLE BETWEEN MH #76 AND MH #78 (SEE SHEET 15), HOWEVER A SHORT RADIUS CURVE IS SHOWN WITH 194± LF DOWNSTREAM OF PI AND 261± LF UPSTREAM OF PI NUMBERING ON MH #76A WAS ADDED FOR TV INSPECTION PROJECT AND MANHOLE APPEARS TO BE APPROXIMATELY LOCATED AT PI.
