CARVINS COVE DAM BREAK ANALYSIS
DAM BREAK INUNDATION ZONE MAP
BOTETOURT COUNTY, VA

PANEL 4

WESTERN VIRGINIA
WATER AUTHORITY

DRAWING NO:
11821007.00

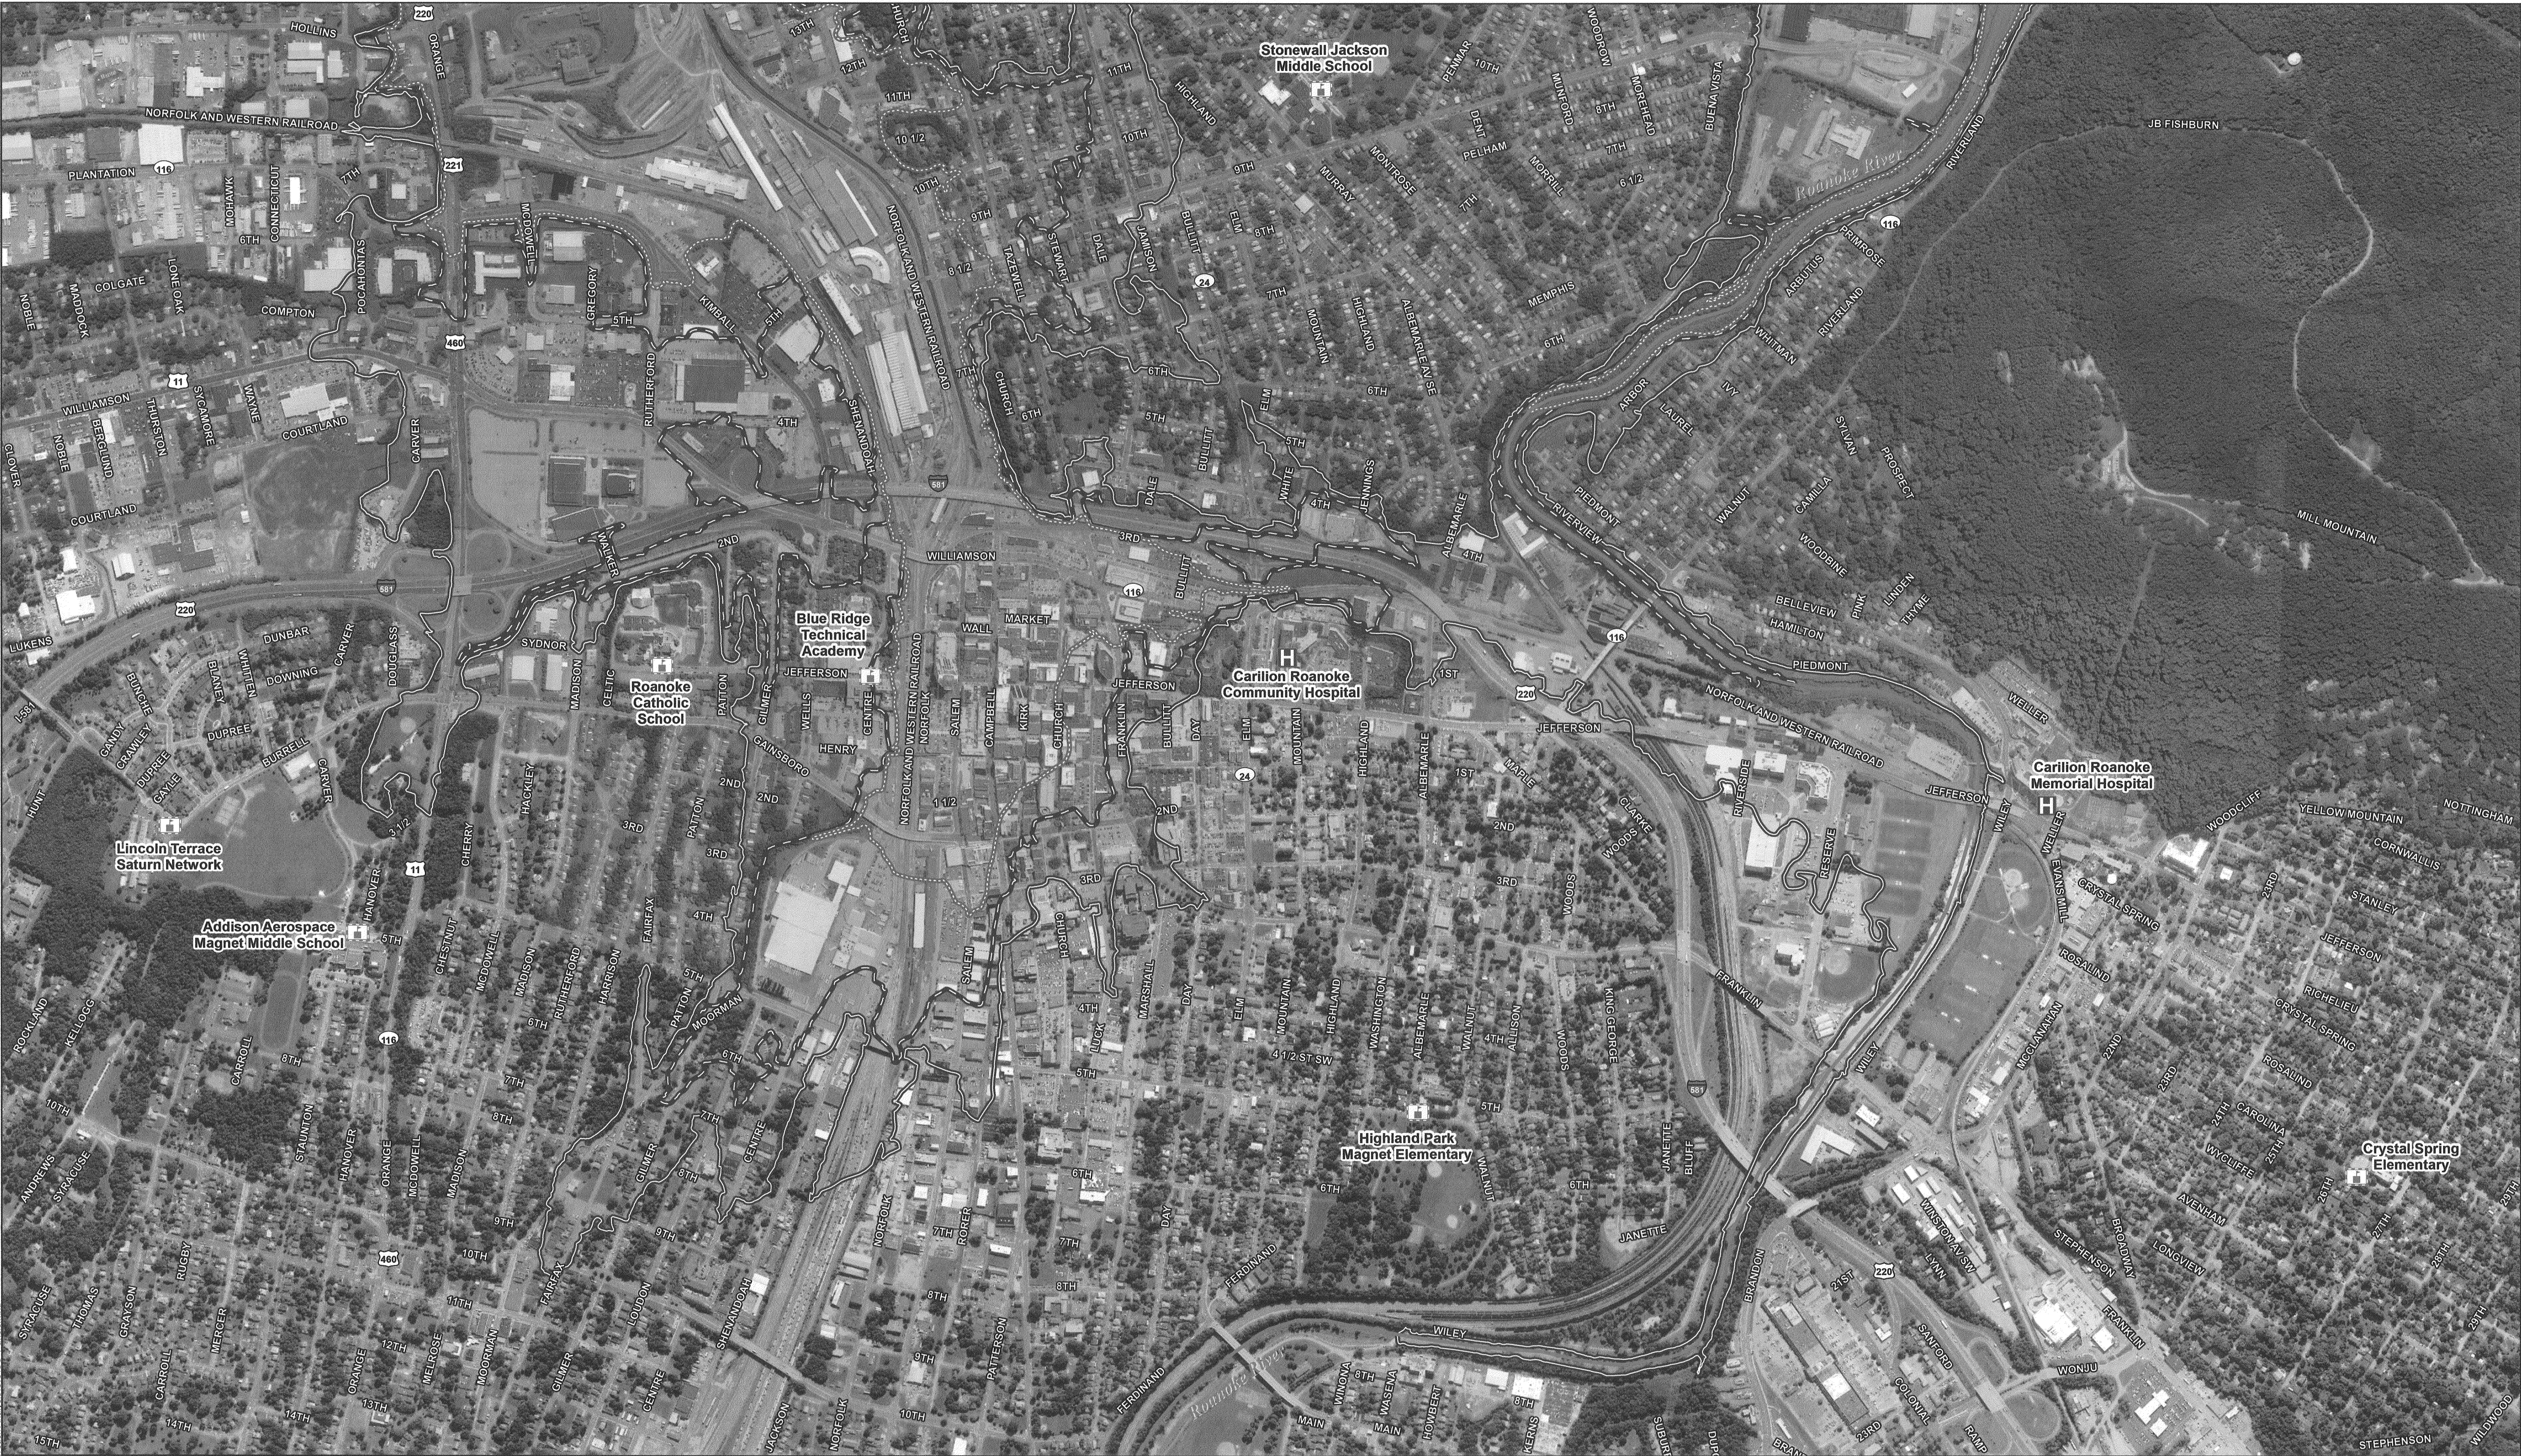
- The information contained in this map is prepared for use in notification of downstream property owners by emergency management personnel.
- Mapping of flooded areas and floodwave travel times are approximate. Timing and extent of actual inundation may differ from information presented on this map.
- It is prudent to assume that areas outside, but adjacent to, the inundation limits shown could also be flooded.
- Due to the topography, floodwave similarities, and map scale, inundation lines may obscure other inundation lines at some locations on the map.
